ANALYSIS OF MUD MOTOR STALLS AND ITS IMPACT ON PERFORMANCE IN HIGH
TEMPERATURE UNCONVENTIONAL RESERVOIRS

A Thesis

ZACHARY IRA HOPKINS

Major Subject: Petroleum Engineering

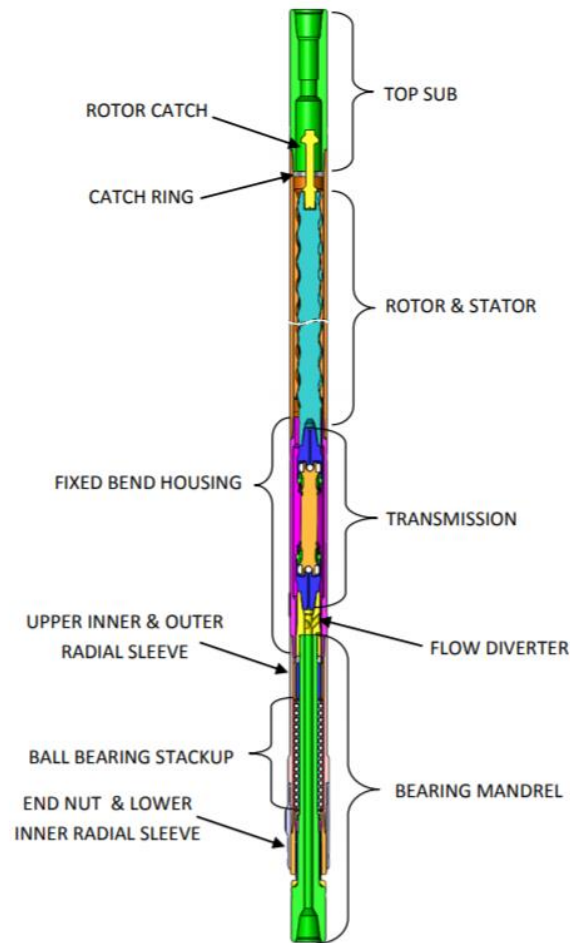
Fig. 3 – Mud motor assembly (reprinted from Weimar, 2011)

seen in **Fig. 3**. The rotor of the power section will have one fewer lobe than the stator to enable discrete amounts of fluid to be pumped and allow the rotor to rotate driving the bit.
